**BLUE
HEELER**

Safety Alert

At Westcliff Colliery in the NSW Southern District an employee working for a contractor tensioning Megabolts had what was first thought to be a hydraulic injection from a burst hydraulic hose. After being examined at Liverpool Hospital it was found to be an abrasion.

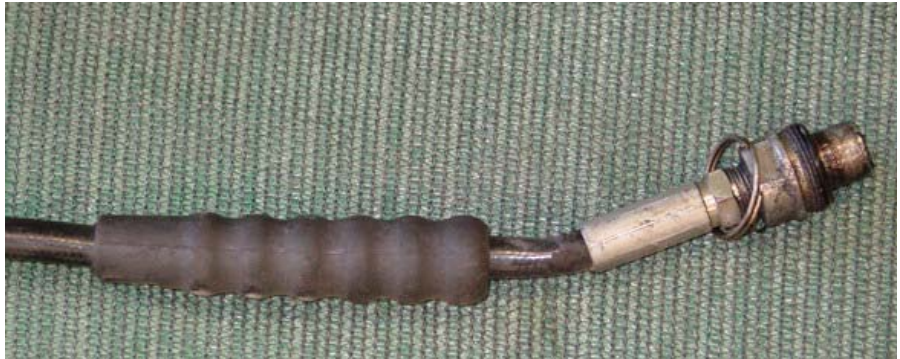
The hose the operator was using was in disrepair with the guard on the end of the hose having slipped down with no protection over the swaging to hose allowing the hose to kink and rupture.

Damaged hose showing guard having slipped down with no protection at swage and hose connection

All hoses are now manufactured with a glued heat shrink sleeve over the guard to stop it sliding down and reducing the ability for the hose to be bent with too tight a radius in the hose protecting the hose where it fits into the swaging.

Any hoses in use without protective ends should be removed from service.

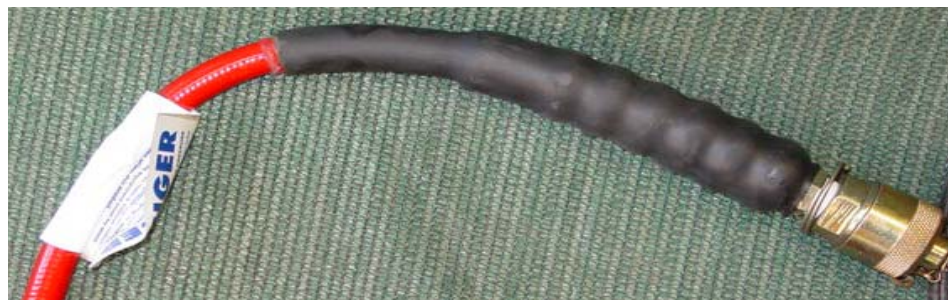
New style hose with glued heat shrink tube keeping guard in place and stopping hose bending at a tight radius. All hoses have safe use guide attached

A safe use guide is now put on all hoses and safe work procedures for using tensioning equipment (copy attached) have been modified to warn operators of dangers.
